Inspection Report Minerals Regulatory Program July 20, 2011

Mine Name: Topaz Mine	Permit Number: M/023/0003
Operator Name: Materion Natural Resources	Inspection Date: July 13, 2011
Inspector(s): Wayne Western DOGM, John Wagner Materion	Time: 8:30 am – 11:45 am
Other Participants:	Mine Status: Active

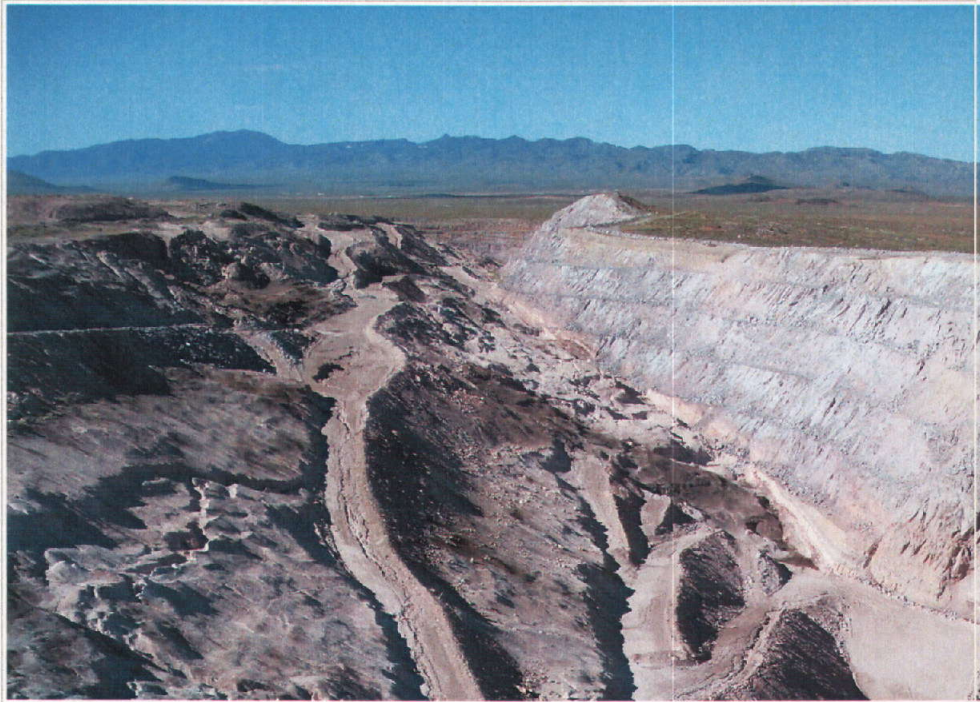
Main active pit

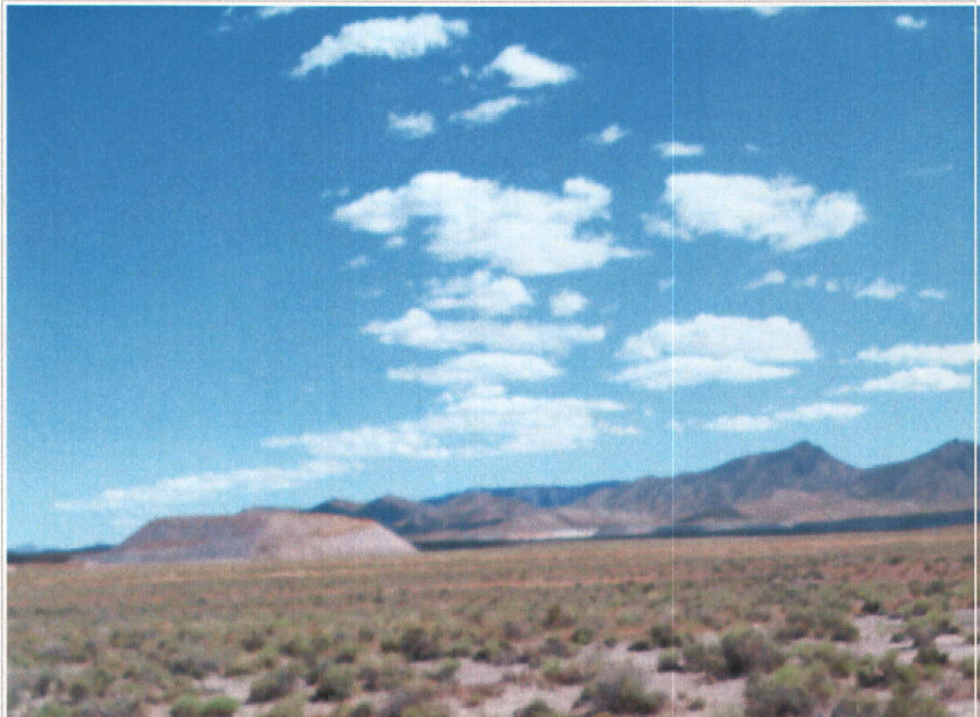
Mine site looking to the north

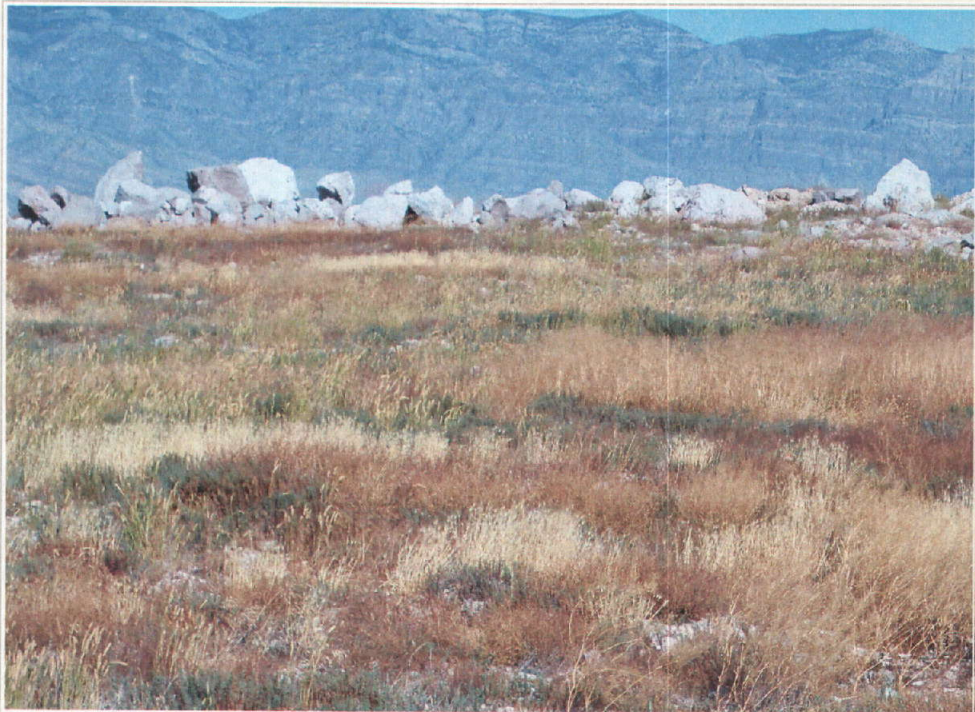
The Permittee is active in concurrent reclamation. The general plan is to reclaim each spoil pile once it has been finished.

Reclamation efforts, vegetation and rock piles to support wildlife

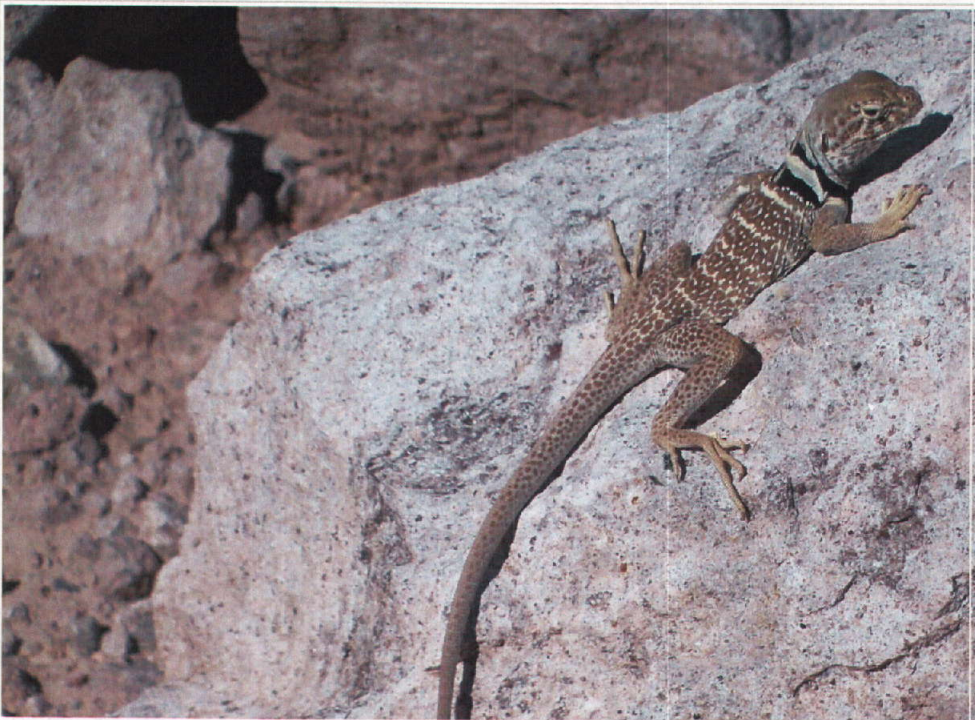
Rock piles provide habitat for small animals
